## **‘O’ Street Anchored Precast Lagging and Soldier Pile Retaining Wall**

Dan Thome, E.I.T.  
Nicholson Construction Company, Kalamazoo, Michigan

Presented at:  
Contemporary Solutions to Land Mass Stabilization  
IX Great Lakes Geotechnical Geoenvironmental Conference  
Dayton, Ohio  
May 11, 2001

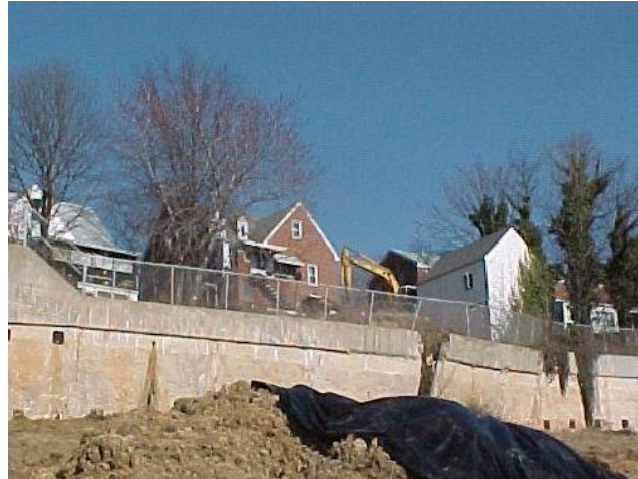
In the winter of 1995 excessive ground movements were noted in approximately 150 feet of the slurry wall. Ground movements were recorded on this particular section of the wall and continued until the spring of 1996 when eventually this section failed. Maximum deflections in the order of 13 feet downslope were recorded. Through time the ground anchors became overloaded and failed causing a global stability failure with a distinct slide plane reaching completely under the toe of the slurry wall.

After the failure an extensive investigation was done to determine the cause of the global failure in this particular area. The forensic study determined the events that lead to the eventual failure of the section of slurry wall was first attributed to improper drainage from behind the wall, which increased the earth pressures acting on the wall. In turn this increase in earth pressure overloaded the tiebacks, failing in part due to the lack of sufficient corrosion protection around the ground anchors. Finally, subsurface investigations concluded that the toe of the slurry wall was actually embedded in a stratum of slickensided clay, which created a less resistant path for the failure plane.
