Remediation of RCC Dam Seepage Upper Stillwater Dam Rehabilitation – Phase 1

Presented at:
USSD Annual Meeting
Salt Lake City, Utah
June 6-10, 2005

REMEDICATION OF RCC DAM SEEPAGE UPPER STILLWATER DAM REHABILITATION – PHASE I

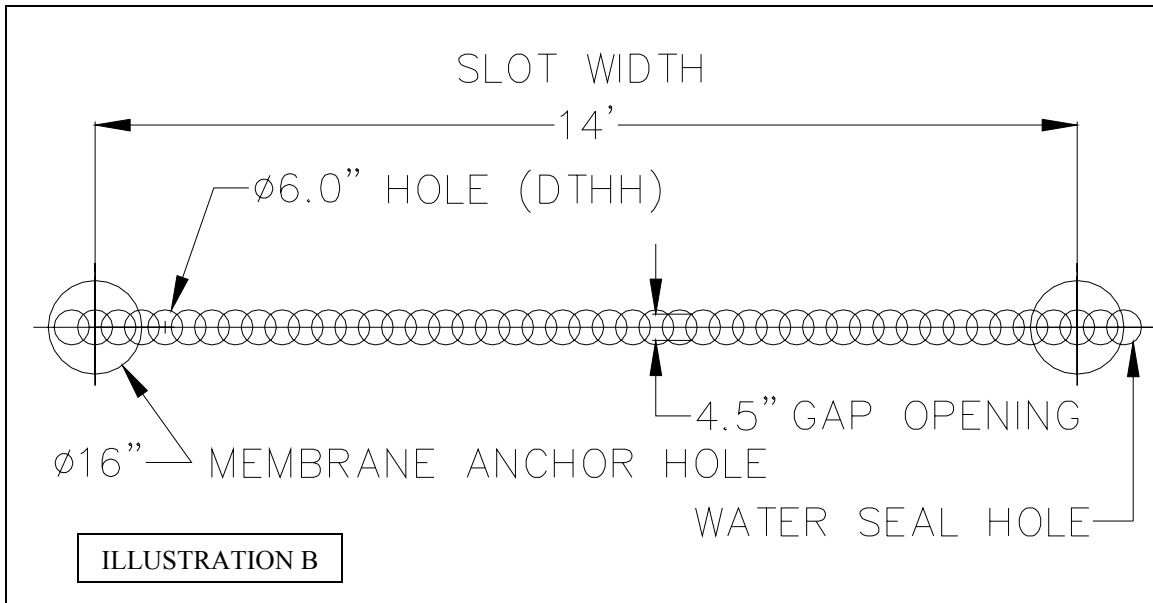
concern in the decision making process for choosing the method of excavating the slots. Illustration B diagrams the slot configuration as originally envisioned. However, a more extensive stress analysis of the stainless steel membrane when placing the hot asphalt necessitated a change in the slot design as well as the placement procedure in order to allow the membrane to fully expand and contract through the cooling cycle of the asphalt.

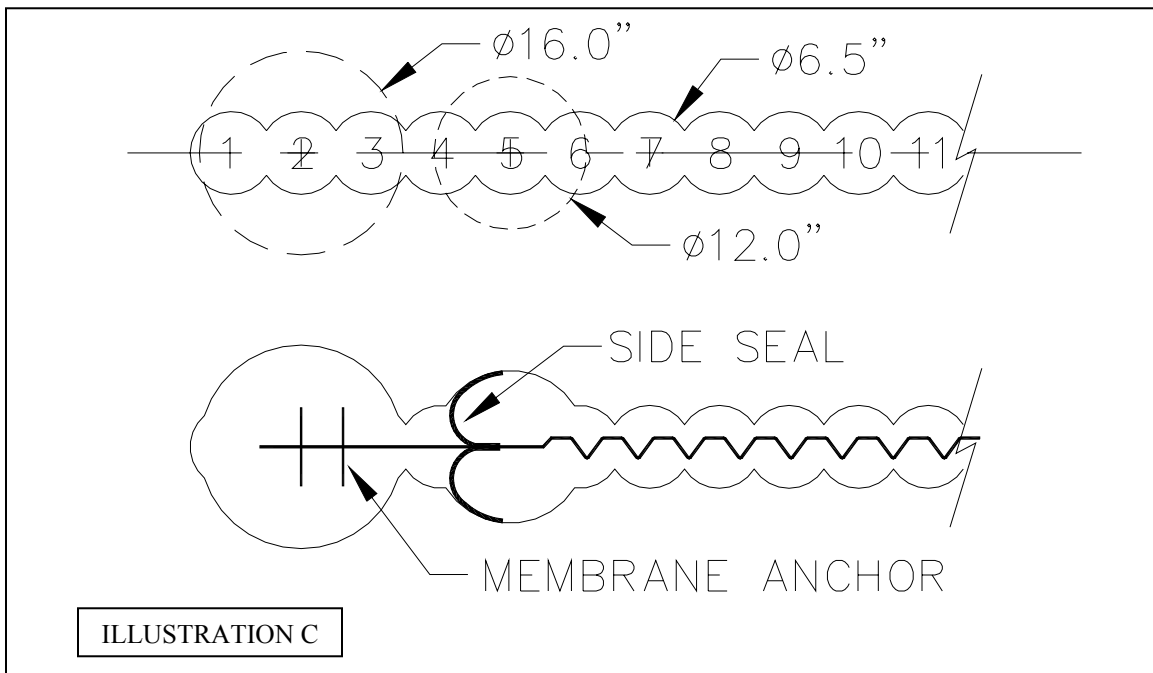
The final slot configuration featured two enlarged holes on either end of the slot to accommodate the revised placement of the side seals – Illustration C.

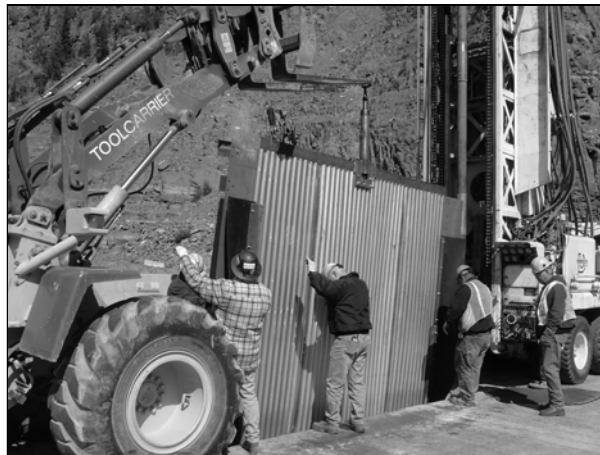
Installing verification “Test Panel” into slot.

On completion of the slot drilling program, all cuttings and extraneous materials were removed from the slot and side holes as part of a final cleaning/bottom dredging process. The walls of the side holes were cleaned using a high-pressure water blaster to remove any drill cuttings, sludge and/or debris in preparation for installing the membrane system. One final procedure prior to installing the stainless steel membrane system was to run a test panel the full depth of the slot. The membrane test panel was full width including side anchor/seal mechanisms to verify clearance and alignment tolerances of the slot.
