Rehabilitation of an Existing Mechanically Stabilized Earth Wall Using Soil Nails

Presented at:
DFI's 30th Annual Conference on Deep Foundations
Chicago, Illinois
September 22-24, 2005

The Illinois State Toll Highway Authority awarded Contract RR-03-5144 in the summer of 2004. Construction work for the project consisted of the rehabilitation of two existing concrete culverts and approximately 100 linear feet (31 m) of mechanically stabilized earth (MSE) retaining wall. The retaining wall is located below the southbound lanes of the Tri-State Tollway near the intersection of Federal Highway 41 in Wadsworth, Illinois as shown in Figure 1.

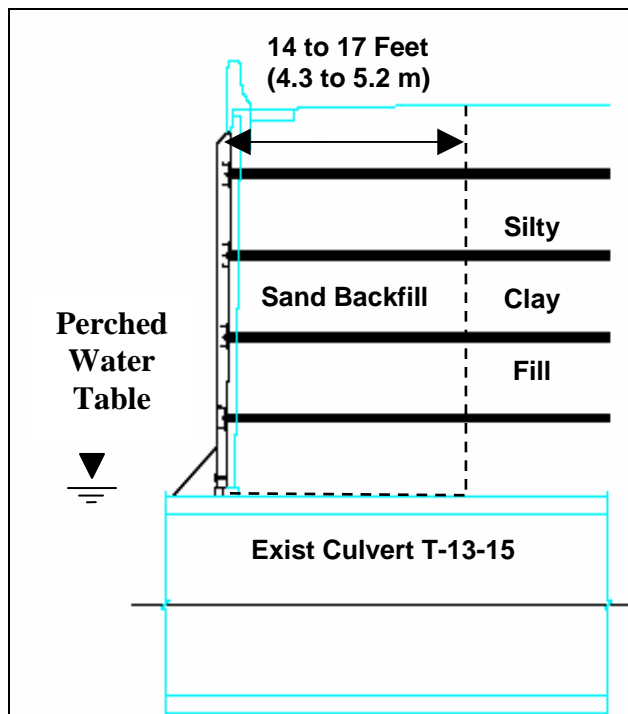
Figure 2 Typical Cross Section - Station 1346+00

According to the wall manufacturer, displacements were noted shortly after construction of the MSE wall directly over the existing culvert. Unfortunately, a monitoring system was not put into place and no corrective measures were implemented on the wall after the displacement had occurred. Refer to Figure 2 for a typical cross sectional profile near station 1346+00.

Stiff to very stiff silty clay fill was encountered below the MSE wall backfill and within the retained soils behind the retaining wall. The depths of this soil ranged from 19 feet (5.8 m) to 33 feet (10 m) below the ground surface. A very stiff to hard natural silty clay soil was reported below the silty clay fill to the maximum depths explored. A perched groundwater table was determined to be near the ground surface in front of the displaced MSE wall section. Figure 2 shows a typical geologic section for the MSE wall near station 1346+00.

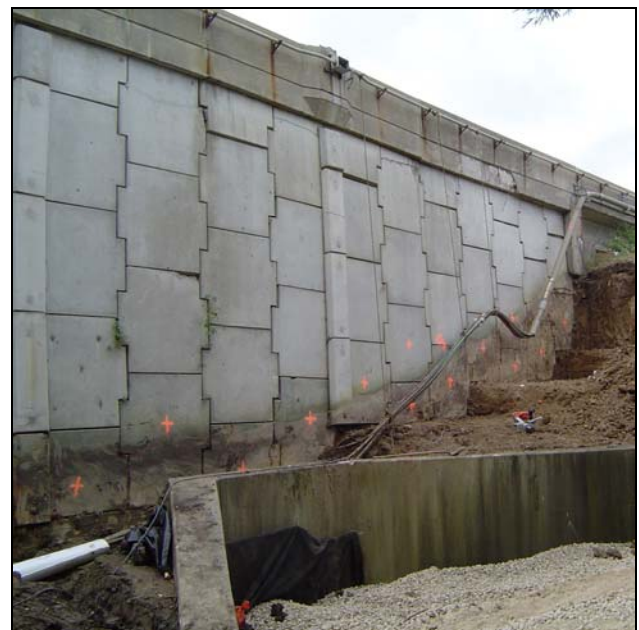
Photo 1 Pre-Construction Condition

- Approximately 2 to 11 inches (51 to 279 mm) of horizontal displacement was reported within the height of the wall.
- The existing 15 inch (381 mm) storm sewer pipe was obstructed with debris, causing perched water near the ground surface in front of the wall.
- Sand backfill accumulated in front of the wall due to loss of ground within the MSE wall backfill.
- Very loose to loose sand backfill was sampled within the failing section while medium dense sand backfill was encountered in the remainder of the wall.
- Vehicular collision with concrete parapet occurred directly above the failing wall section.
- Concrete panels were grossly misaligned due to excessive horizontal displacements causing spalling at the edges near vertical shear pins.
- Notable settlement of the Tri-State shoulder above the wall indicated redistribution of soil within the sand backfill.

Causes of the distress in the MSE wall were inconclusive in the reports, but undoubtedly a combination of the above factors caused the horizontal displacements.

Option A-2 was chosen because the cast-in-place reinforced concrete maintained the existing appearance of the MSE wall. Also, it was more economical to build option A-2, when compared to option A-1, based on preliminary cost estimates performed by the owner’s engineer. Options B and C were eliminated due to aesthetics and vibration concerns based on conversations with the Illinois State Toll Highway Authority.
