CANTON LAKE DAM AUXILIARY SPILLWAY EXCAVATION

Canton, OK

PROJECT BACKGROUND

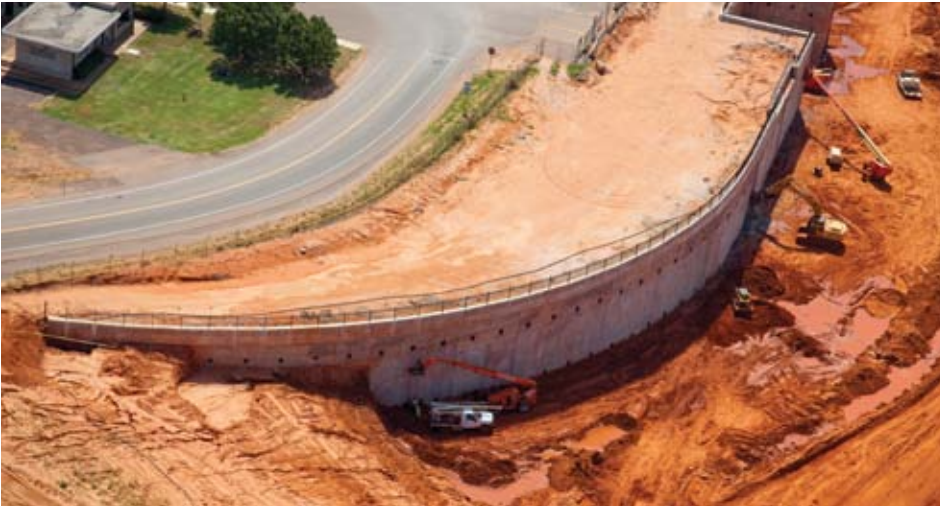
Northern diaphragm wall

The excavation was supported by diaphragm walls with permanent anchors. Diaphragm walls were used because they reduced the need for additional excavation and side-sloping for trench safety and stability that conventional reinforced walls require.

The auxiliary channel was made up of two, 730-foot-long diaphragm walls. Together, the north and south channel walls totaled 79,000 square feet of diaphragm wall. The creation of the wall required 6,850 cubic yards of concrete and 500 tons of steel.
