## GILBOA DAM

Gilboa, NY

### PROJECT BACKGROUND

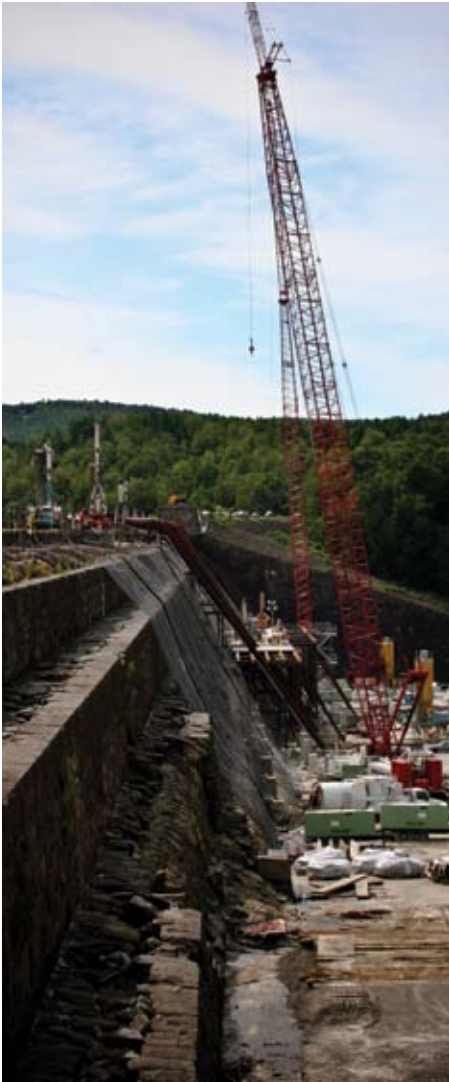
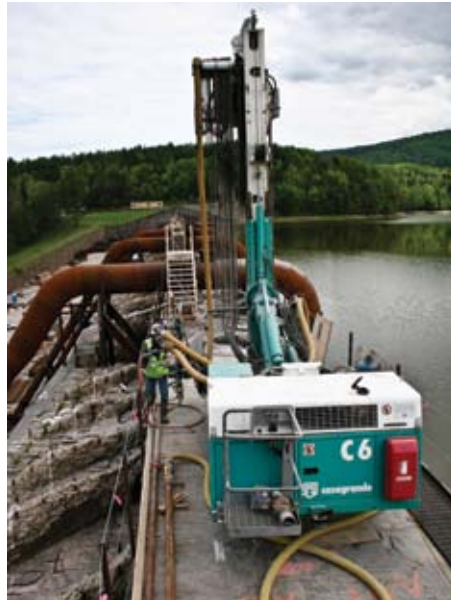
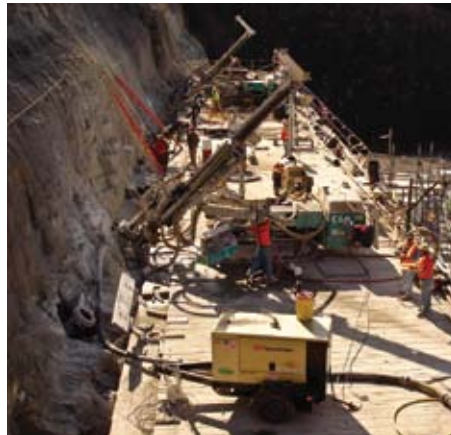
Overview of drill platform and work area (left); Drilling vertical tie-downs (top right); Rigs drilling incline anchors through the dam (bottom right)

Five drilling rigs were used to install the 79 high-capacity rock anchors in the dam crest and downstream face to improve the overall stability of the dam. Forty-seven of the anchors were drilled vertically through the dam crest and 32 inclined anchors were installed through the dam face from a temporary work platform, which was also designed and constructed by Nicholson. The anchors ranged in

length from 107 to 237 feet and had loads of 1,370 to 2,040 kips. The largest anchors had 58 strands.
