## **‘O’ Street Anchored Precast Lagging and Soldier Pile Retaining Wall**

Dan Thome, E.I.T.  
Nicholson Construction Company, Kalamazoo, Michigan

Presented at:  
Contemporary Solutions to Land Mass Stabilization  
IX Great Lakes Geotechnical Geoenvironmental Conference  
Dayton, Ohio  
May 11, 2001

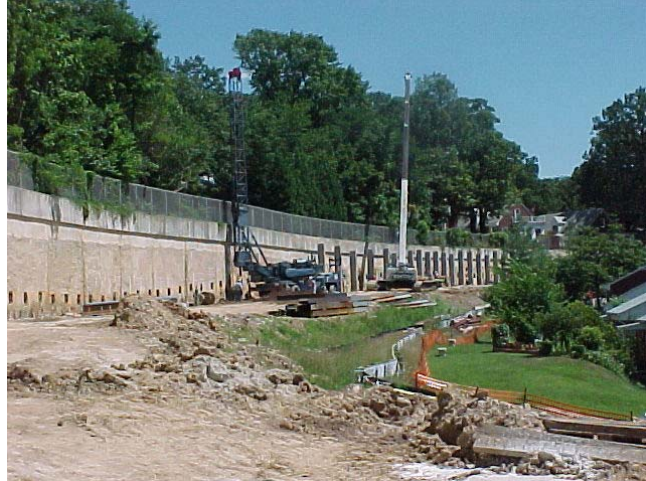
Perched water tables on the eastern side of the construction site caused saturated sandy silt seams to develop in the upper 30 feet of each hole. A couple of techniques were utilized to try and remedy these problematic conditions. Casing approximately 36 inches in diameter was placed in the upper portion of the hole in order to eliminate any loss of ground. The beam was then placed in the drilled shaft and concrete was poured to the bottom of the casing. After the concrete had cured overnight the casing was filled with concrete and then removed using a Mantis crane. This particular method was found to cause

problems when setting the beams at their designed locations. Proper placement of the soldier beam was found to be very difficult once the lower portion of the beam was fixed.

An alternative to casing was to drill a 42-inch diameter hole approximately 5 feet past the running sands and then fill the hole with a low strength lean mix concrete. Lean mix concrete would then be redrilled the following day using a 36-inch auger. The lean concrete would then stabilize the upper portions of the hole and the lower portions would be self-supportive due to the hard clay consistency of the soil. Longer cure times on the lean concrete prompted a rock auger to be used when drill times began to exceed anticipated durations. This problem caused the field crew to reduce the amount of drilled shafts being opened and filled with lean mix each day. This particular method was found to be time consuming but more practical than casing. The lean concrete was used for drilled shaft stabilization throughout the eastern part of the wall.

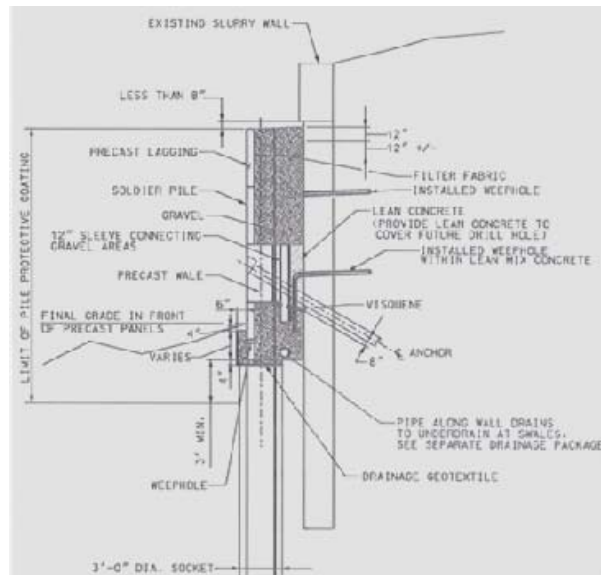
To promote a drainage path for water to flow between the new and existing slurry wall a 4-foot wide prefabricated drainage composite was placed between each bay and extended 1-foot out from the face of the new wall. Gravel was

then placed on top of the prefabricated drainage composite with the extra filter fabric wrapped over the gravel and tucked behind the face of the wall. The bottom precast concrete panel was then set on top of this piece of filter fabric using a crane and wedged into place with wood braced against the back flange of the soldier beam. Additional gravel was then placed behind the panel and the existing slurry wall. All panels, with the exception of the top panel, were cool gray with a split slate texture.

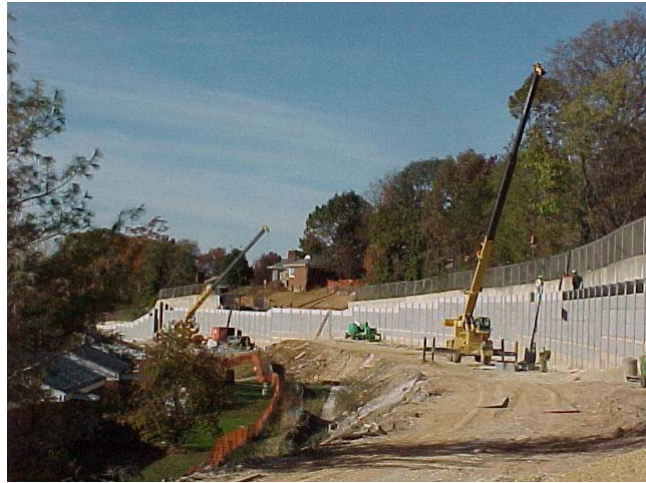
Prior to setting the 4-foot high by 2-foot wide plain smooth concrete waler, existing anchor locations on the slurry wall were compared to proposed anchors through the new wall. If any of the new anchors were expected to hit an existing anchor bearing plate the waler would be slid to one side if clearance of the bearing plate could be accomplished. As a last resort a portion of the bearing plate would be burned off to clear the way for the path of the new ground anchor. To help prevent new anchors from interfering with one another the right trumpet was set in the precast waler at 30 degrees while the left trumpet was set at 27 degrees. Walers were then set into their respective bays using a Mantis crane. Nonshrink grout was poured in the voids between the soldier pile and waler.

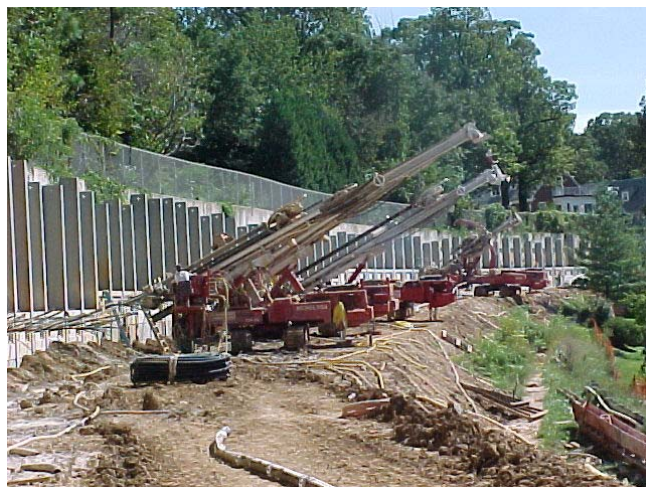
Drills were set up to external flush with air and water using drop off bits. These techniques were found to be unsatisfactory because drill cuttings were not getting removed from the hole due to a loss of pressure. Air and water were found to be escaping through the more permeable soil layers during drilling operations.

Field personnel noted that the saturated clay and sand lenses were typically located within the top 50 feet of the anchor hole and suggested shortening the amount of casing installed. Drilling operations began to run casing for the first 30 to 50 feet of the hole and then drill the remaining

length with an open hole. Great care was taken to clean out the hole prior to anchor installation. PVC centralizers, 5 inches in diameter, were used to keep the corrugation from dragging through the soil and to concentrate the anchor in the center of the hole when installed. These centralizers were placed in 5-foot increments throughout the bond zone.

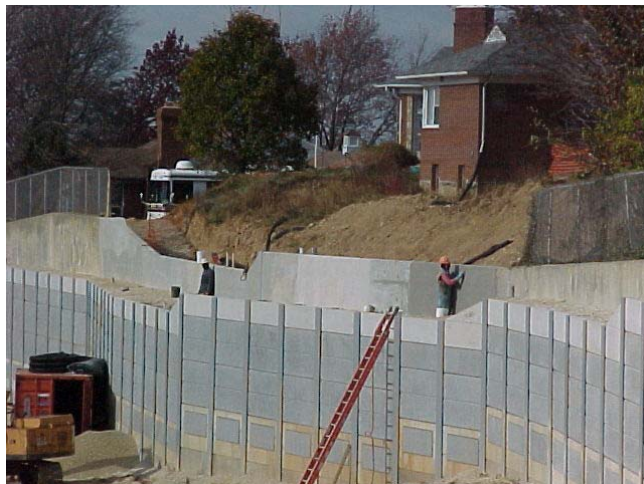
The two existing slurry wall panels where demolition stopped were sawcut vertically through the existing concrete cap to get a flush tie in with the proposed cantilever retaining wall. Approximately 20 feet of the already demolished panels had additional demolition done in order to reduce the overturning moment on the failed panel and to also give a 2-foot clearance for the footing of the retaining wall. 2 feet of clearance was needed to reduce the variation in bearing material underneath the cantilever retaining wall. Therefore, with the additional demolition there was approximately 1 to 2 feet of gravel fill under the entire length of the wall footing.

Natural grade in the failure area was cut into slightly in order to account for the dimensions of the cantilever retaining wall. The existing subgrade was compacted to 95% of ASTM D698. Geotextile was then placed on top of the existing grade followed by gravel backfill up to the required footing elevation for the cantilever wall.
