DESIGN-BUILD SUPPORT OF EXCAVATION FOR BLOCK 76

Rick Deschamps and Tom Hurley, Nicholson Construction, Pittsburgh, PA USA

The Block 76 project includes the demolition and redevelopment of an entire city block for mixed use retail, office and residential properties directly adjacent to Historic Temple Square in Salt Lake City, Utah. Excavation was carried out 65 ft below street grade and by as much as 50 ft directly below adjacent buildings supported by shallow foundations. Movements of the earth retention system and adjacent buildings were monitored in real time using automated equipment which complemented traditional geotechnical instrumentation. In the areas immediately adjacent to the existing buildings 9 stories or greater, anchored diaphragm walls were employed. Areas of the site not supported by diaphragm walls employed a soil nail wall system. Jet grouting was used for water cutoff in lieu of dewatering along the north and east sides of project.

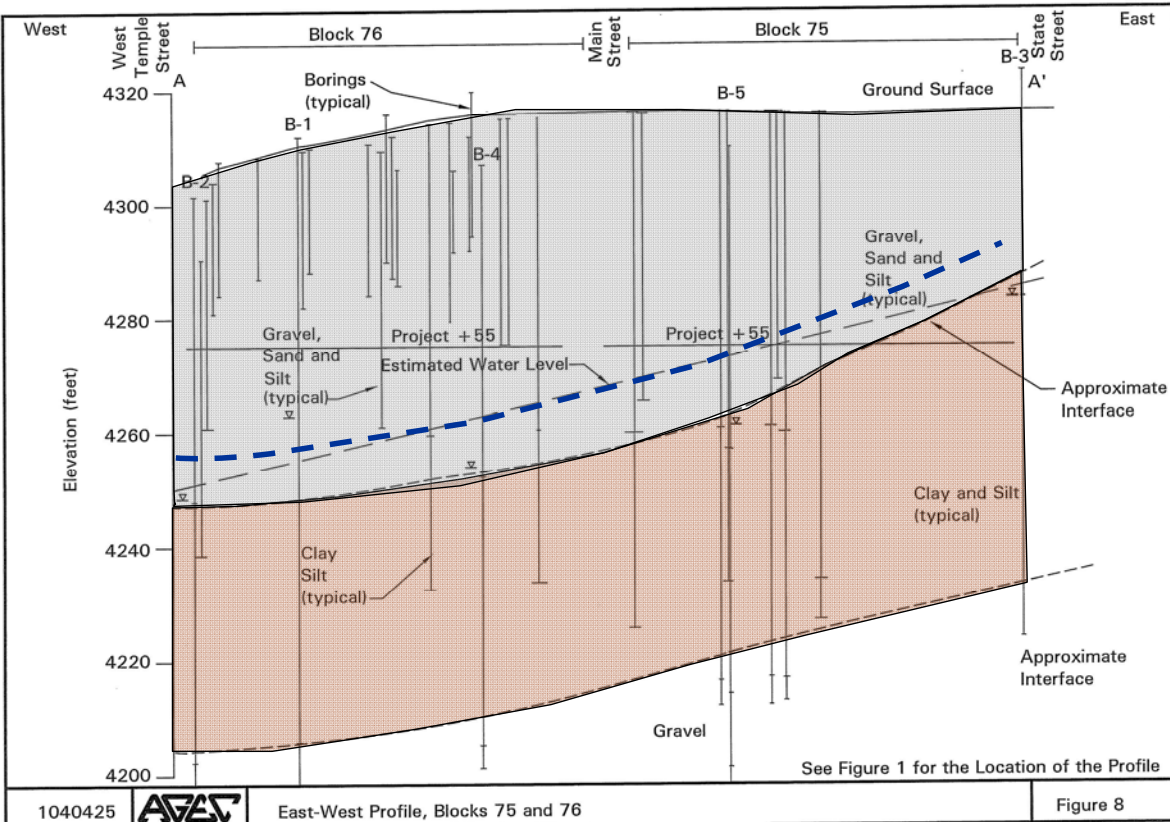
Figure 3 –Idealized Subsurface Profile.

The soil stratigraphy consists of layered alluvial and lacustrine deposits. The uppermost layer was medium to very dense sand and gravel laid down as alluvial fans from the adjacent Wastach Mountains. This gravel layer was underlain by medium to stiff clays and silts under which is a very dense layer of sand and gravel. The clay and lower gravel layer are deepest at the southwest corner of the site and rise towards the northeast corner of the site. The depth to existing groundwater is approximately 40-54 ft below grade with the highest groundwater at the northeast corner of the site. Figure 3 depicts the subsurface profile. (Image from Geotech report prepared by AGECE).

The idealized subsurface profile in Figure 3 shows that the excavation to project Elevation 36 ft would be below the existing ground water at the north east corner of the site. Jet grouting was employed as an alternate to dewatering to mitigate water inflow along the north and east sides of project (Figure 6). A series of overlapping columns was designed to create a cutoff wall in between diaphragm wall segments along the north east part of the site.

geotech report (Figure 3). However, the local conditions were quite different.

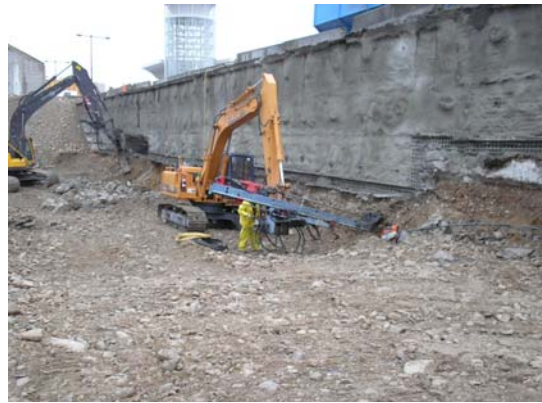
Figure 4 –Concurrent Demolition and Soil Nail Wall Installation.

Soil Nail Walls: The project began with a demolition phase that was supported by soil nail wall construction. As subsurface demolition occurred, the soil nail walls were sequentially installed as earth retention to support further demolition below grade. Figures 4 and 5 show the concurrent demolition, soil nailing and micropile operations

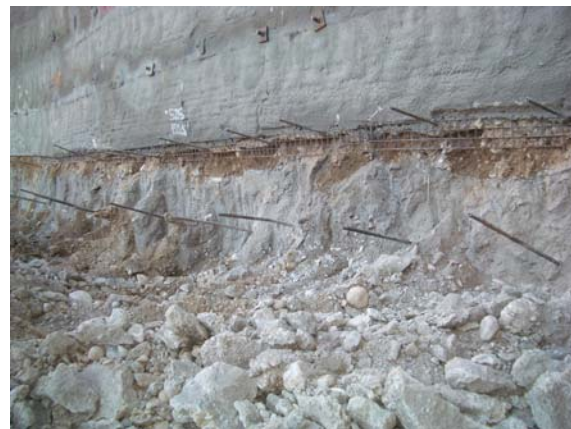
Figure 7 –Jet Grout Wall South Temple Street

The jet grout columns were installed so the bottom of column was keyed into clay about 5-10 ft below the base of the excavation and the top of the column was installed to 5 ft above the known high water elevation determined from the observation well readings. The average drill length for each column was approximately 50 ft and the jet length was 30 ft. A total of 236 columns were installed in a 2 month time frame to complete the water control activities enabling completion of soil nail walls below the ground water table. Figure 7 shows the exposed jet grout wall and completed soil nails.

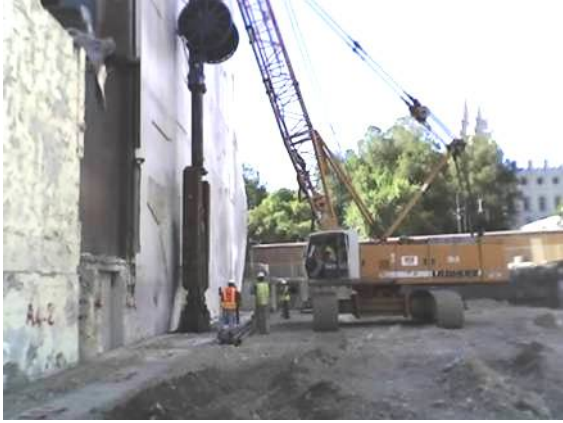
Figure 8 –First Anchored Diaphragm Wall in Salt Lake City June 2007

Diaphragm Wall: Diaphragm walls were constructed adjacent to the Temple View Center Building (9 stories), the Gateway Tower (23 Stories) and the McIntyre and Crandall Buildings (9 Stories). Each building is on shallow foundations, and excavation was required to approximately 40 ft below the foundations.

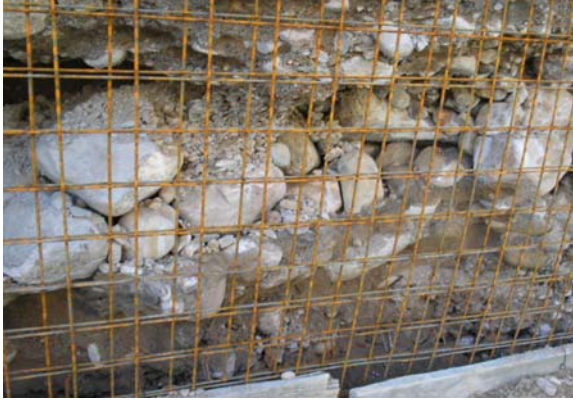
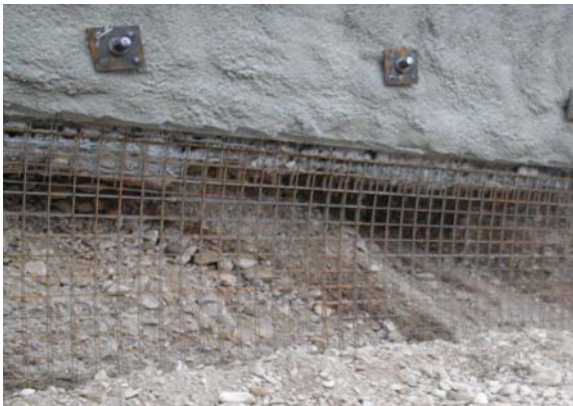
Figure 9. Open coarse cobbly zones (top) and lost ground zones (bottom).

Face stability was a challenge for construction of the soil nail walls in some areas of the project. The material was an excellent representation of surficial geology associated with an alluvial fan deposits (see Figure 9). The coarsest openwork materials would ravel when cutting along directions adverse to the bedding orientation (on north walls). The solution was to fill voids with flow fill after wall placement. The limitations of Standard Penetration Tests are apparent in this environment. Locally, the Modified California sampler is also used, which is an improvement, but still has significant limitations in identifying the extent of the coarsest material in this cobbly ground..

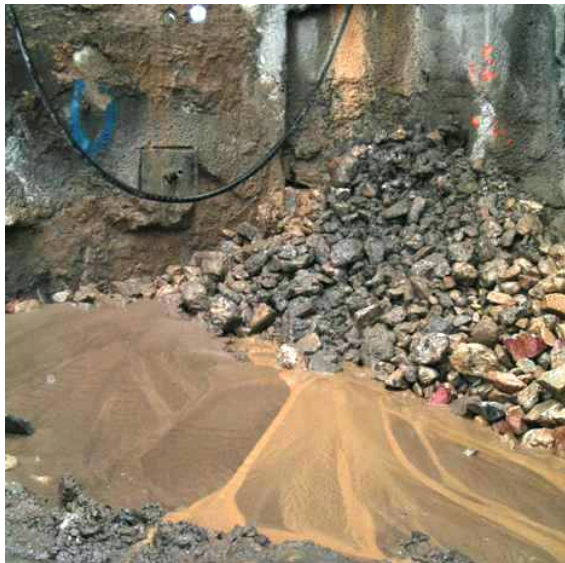
Figure 10. Seepage inflow at the connection between the diaphragm wall and the jet grout cutoff.

Groundwater inflow proved to be a challenge at the connection between the diaphragm wall for the Gateway Tower and the jet grout cut off below the Main Street Garage. An electric duct/vault was present at this location requiring that the jetting be installed from compound angles to try and achieve a seal. Upon excavation it was found that a complete seal was not obtained and some secondary grouting was required using cement and polyurethane grouts. Figure 10 illustrates the stone fill placed at the leakage point to control "lost ground."

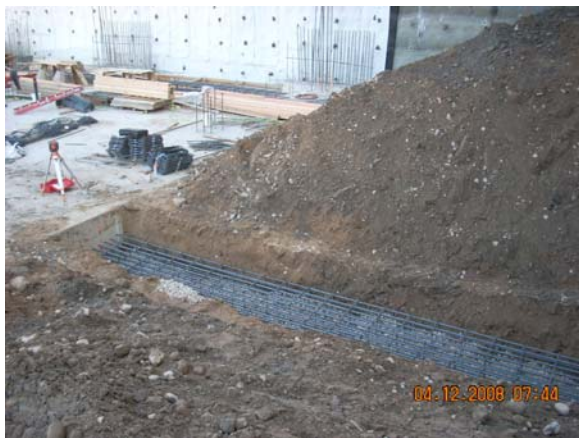
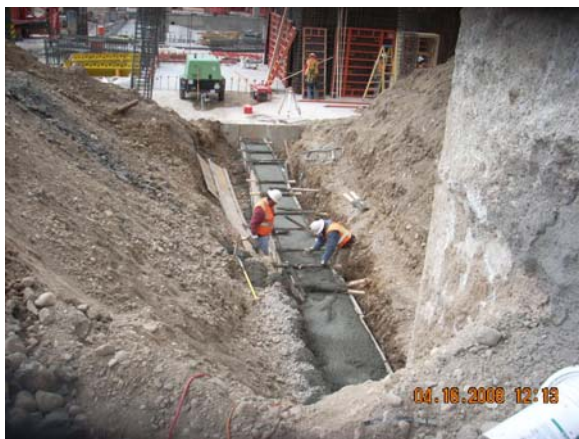
Figure 11. Sequential installation of subsurface struts at west wall of Gateway Tower.

A construction sequence was developed where one strut was excavated, rebar dowels were drilled and grouted, a prefabricated reinforcing cage was hoisted in, concrete was placed, and the entire area backfilled during a single shift (see Figure 11). This process was used to construct 7 struts, and upon sufficient cure time, the soil berm was removed and the new construction was completed.

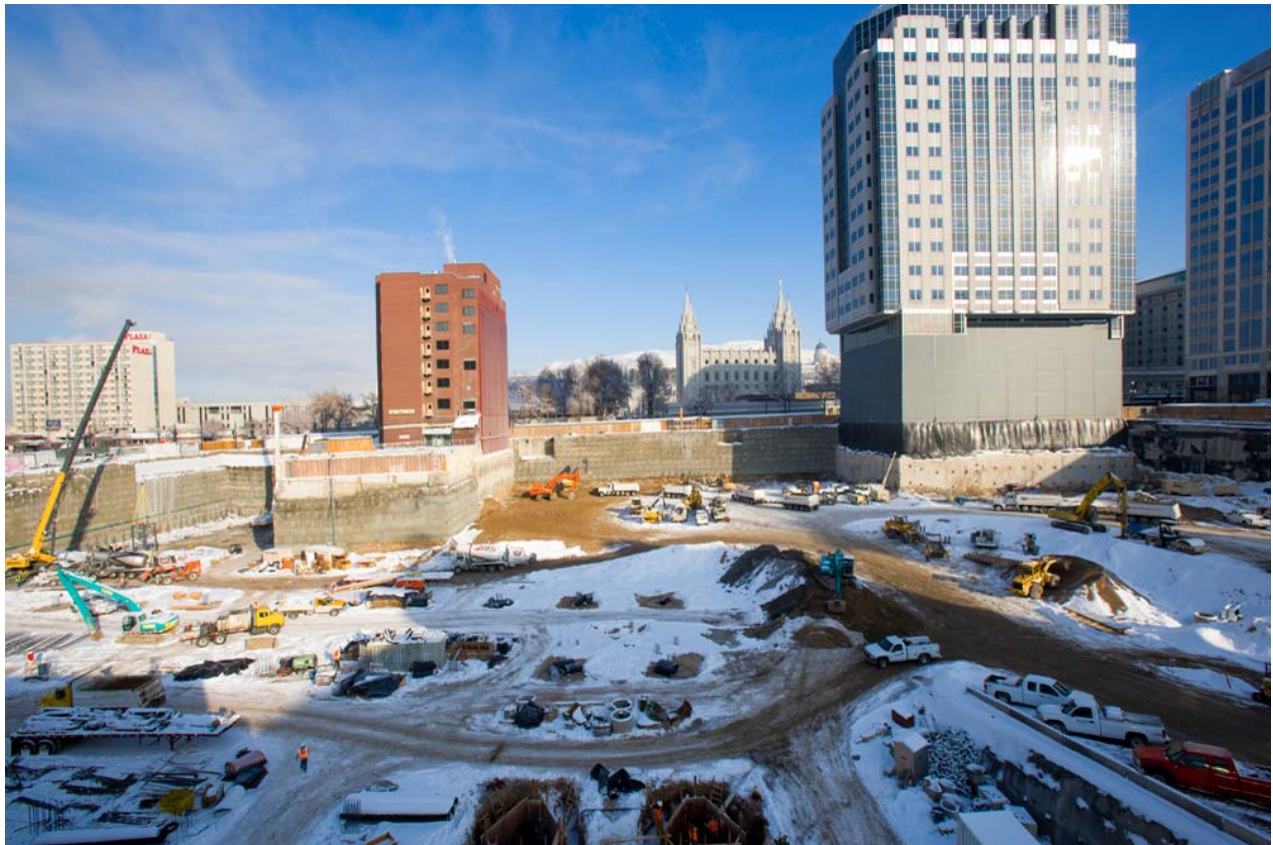
Figure 12. General site view looking north.

The approach employed performed very well with only small additional movements occurring during and after nail installation. Figure 12 depicts a wide angle view of the project and Gateway Tower.
