CANTON DAM Canton, OK

- **Owner:**
U.S. Army Corps of Engineers, Tulsa District
- **Technique(s) Utilized:**
Rock Anchors

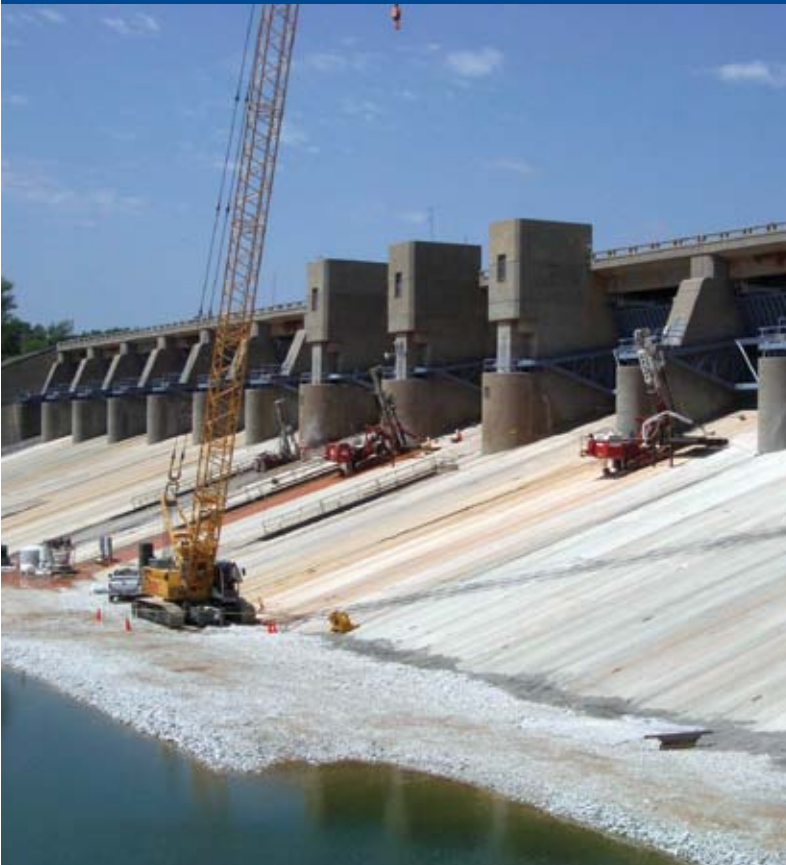
To address the low shear strengths and potential sliding, Nicholson stabilized the 800-foot long concrete spillway with 64 high-capacity, post-tensioned rock anchors. The anchors range in length from 175 to 230 feet and have capacities ranging from 1,500 to 2,200 kips. The largest anchors on the project have 58 strands.
